## Gel Bleed and Rupture of Silicone Breast Implants Investigated by Light-, Electron Microscopy and Energy Dispersive X-ray Analysis of Internal Organs and Nervous Tissue

**Objective:** We studied a patient who died in 2008 at the age of 56 and had been exposed to gel bleed from her silicone breast implants for 17 years. Tissue samples and nervous tissue could be obtained for analysis.

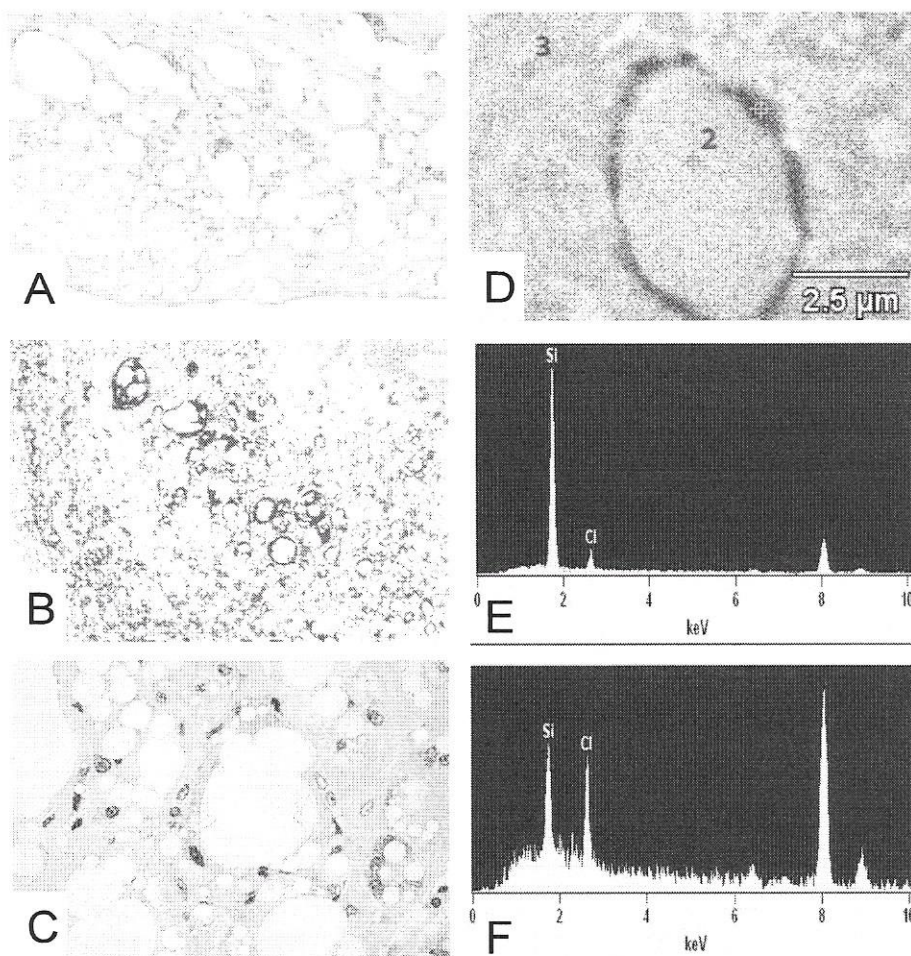
**Figure 1:** (A) A histological 4 µm paraffin cut of the capsule surrounding the silicone implants from patient 2 with bleeding and complete rupture of the implant. As can be seen there are numerous vacuoles which are, as viewed by a higher magnification, filled with threadlike structures of translucent amorphous refractile non-polarizing material suggestive of silicone deposition (HE staining); (B) A histological 4 µm paraffin cut from the capsule surrounding the silicone implant from patient 2 stained with the MORO to demonstrate if the translucent amorphous thread like structures are stained. As can be seen strong positive stained material is present, particularly located perivacuolar; (C) A higher magnification of the semi thin toluidine blue stained cut from the capsule surrounding the silicone implants of patient 2. As can be seen clearly there is a vacuole partially filled with threadlike structures of translucent material. Also here the vacuoles are not completely filled with the material, suggesting there is material lost in the processing steps. The embedding of the tissue in epon makes it inappropriate to visualize (stain) the silicone with the MORO staining. EDX analysis is performed to conclude if high concentrations of silicone are measurable; (D-F) EDX spectra and EDX analysis of a non contrasted 200 nm EPON section from the capsule surrounding the implant from patient 2. Top right image shows three measuring points. Point 1 is on the electron dense perivacuolar material, point 2 and 3 are in and around the vacuole; As can be seen in spectra 1 there is a high peak of elemental silicon at 1.74 KeV (E); In measuring points 2 and 3 there are considerable less amounts of elemental silicon found and stay under 500 silicon net counts (F). With this in mind we have set a standard: net counts lower than 500 are negligible and counts over 1000 are of silicon stacking and of pathological interest. As can be seen in measure point 1 there are 6626 Si- counts and thus suggestive for silicone stacking. Chlorine peaks found at approximately 2.6 KeV are originating from the EPON, peaks at resp. 8 and 9 KeV are due to copper, used as material for the grid holder. Both peaks can be ignored. Picture E EDX on dense perivacuolar material (point 1). Si count 6.626, Inside the vacuole (point 2). Si count 302 and picture F EDX on the surrounding tissue (point 3). Si count 447. Original microscopic magnification A-B 50x, C 400x.

comprised of elemental silicon and titanium. The vacuoles (droplets) are comprised of elemental silicon. Thus we identified two variants of silicone containing material. These were also found in macrophages. Different stainings are the MORO silicone staining and Sudan Black/Normal ORO fat stains which have been performed on a silicone positive paraffin control, consisting of a peri prosthetic capsule. Also electron microscopical investigation and EDX analysis was done on this positive control. Questions about the specificity of the MORO staining for silicone in freeze and paraffin cuts could thereby be established (figure 1).

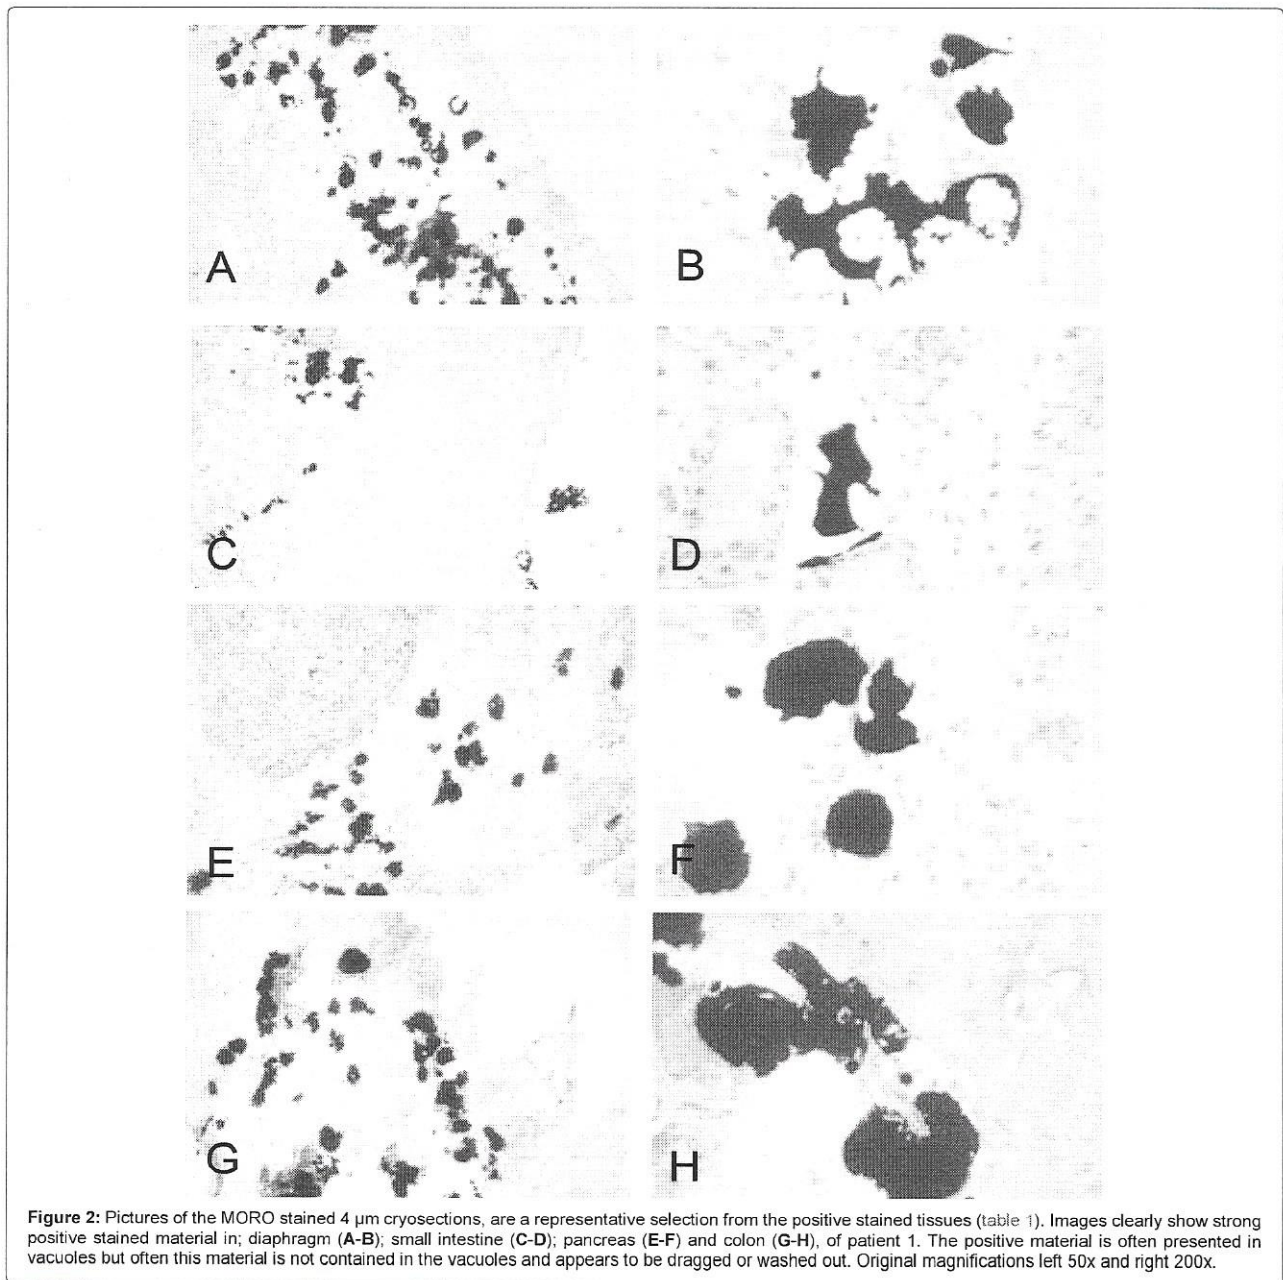
**Figure 2:** Pictures of the MORO stained 4 µm cryosections, are a representative selection from the positive stained tissues (table 1). Images clearly show strong positive stained material in; diaphragm (A-B); small intestine (C-D); pancreas (E-F) and colon (G-H), of patient 1. The positive material is often presented in vacuoles but often this material is not contained in the vacuoles and appears to be dragged or washed out. Original magnifications left 50x and right 200x.

The Modified Oil Red O (MORO) staining was initially performed on 4 µm freeze cuts from frozen material of our patient, acquired in body autopsy. This first staining was performed to check if any positive material is present and stainable. Results of this first MORO staining show large quantities of positive stained material in a large range of tissues. (Table 1 and Figure 2).

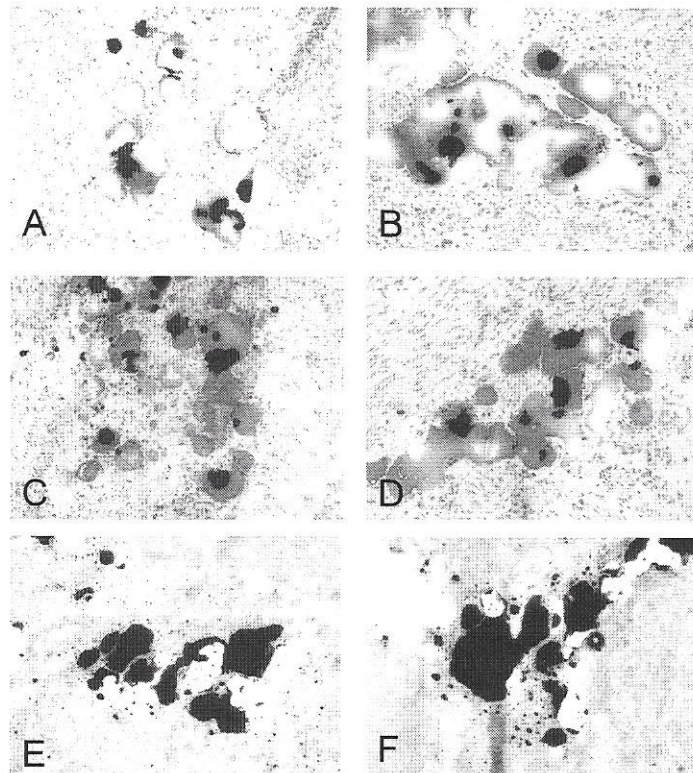
**Figure 3:** Pictures all show the same freeze cut of the frozen urinary bladder from patient 1 fixated with different fixatives previous to MORO staining. All left images are 4  $\mu$ m thick, all right images are 9  $\mu$ m thick. Panel A/B 15 minutes 4 % buffered formalin fixation. Panel C/D shows 15 minutes 2% glutaraldehyde fixation. Vacuoles are both in the 4 and 9  $\mu$ m cuts completely filled with positive stained material. Panel E/F shows 15 minutes 2% glutaraldehyde + 15 minutes 2% osmium tetroxide fixation. As can be seen in all panels there is a significant amount of positive material present. Original magnification: all 100x.

To ensure that the frozen material from patient 1 also contains the silicone after treatment with different fixatives we performed MORO staining on different samples. As can be seen in all panels there is a significant amount of positive material present (Figure 3).

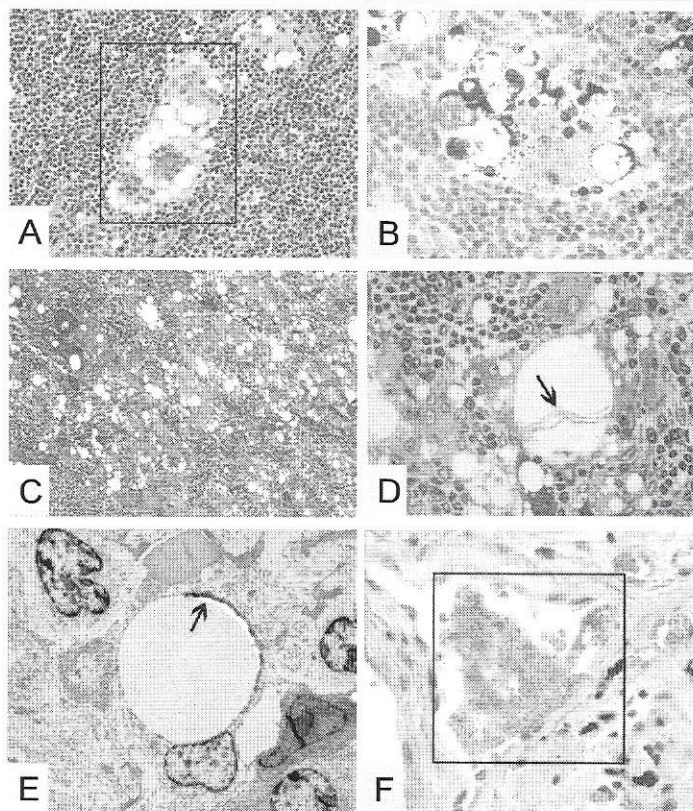
**Figure 4:** Multiple lymph nodes of patient 1 were filled with large quantities of multinucleated giant histiocytes in presence of possible exogenous material, suggestive of silicone A-E. (A) A 4  $\mu$ m paraffin cut stained with Hematoxylin and Eosin in presence with a giant histiocyte and cytoplasmic vacuoles filled with, when viewed with higher magnification, translucent amorphous material; (B) A 4  $\mu$ m paraffin cut stained with the MORO, positive stained material is present inside the giant histiocytes; (C) A 1  $\mu$ m toluidin blue stain where multiple giant histiocytes are seen in presence of multiple vacuoles; (D) A higher magnification of the toluidin blue stain where threadlike translucent material is present inside the vacuoles; (E) A TEM micrographs of a vacuole with dens perivacuolar material, on this dens material EDX analysis is performed, see details Figure 5 A-B. Often material is clearly located inside a bloodvessel, this event can be found throughout all tissues (F). Original microscopic magnification; A/B and D/F, 400x, figure C, 200x and figure E 5000x

Also different lymph nodes were excised for histological examination and showed extensive foreign body reaction in the presence of many epithelioid multinucleated giant histiocytes and the presence of translucent material, suggestive for silicone. MORO positive stained material is located inside vacuoles and histiocytes (Figure 4). Samples are cut approximately 100 and 200 nm thick for assessment in TEM and analysis by EDX. EDX analysis is performed on this lymph node material to see if large amounts of elemental silicon is measurable. (Figure 5).

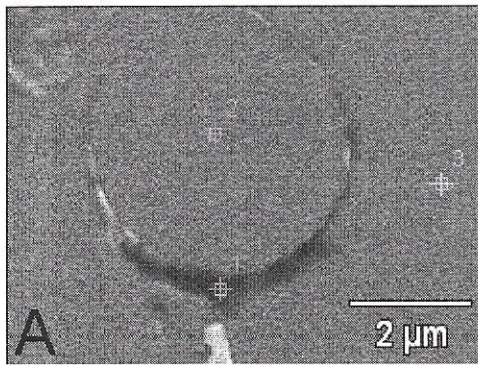
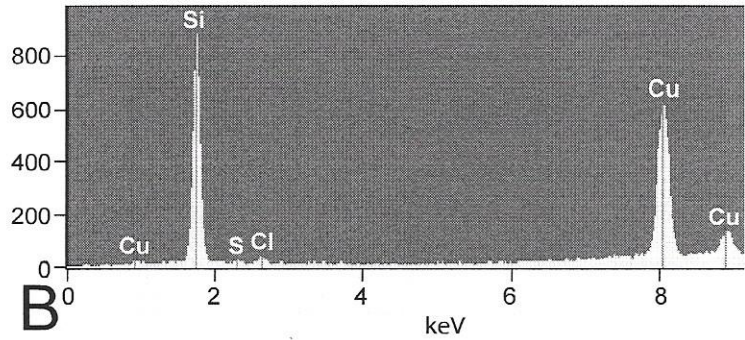
**Figure 5:** TEM micrograph of the EDX measuring points performed on the lymph nodes of patient 1. Point 1 is on the dens perivacuolar material. Point 2 is inside the vacuole and point 3 is on the surrounding tissue (A); EDX analysis of patient 1 lymph nodes from the subcutaneous swelling in the left armpit. Point 1 (spectra 1) = 10759 Si-counts (B). As can be seen in measuring point 1 there is a large peak of elemental silicon found which corresponds with the electron dens perivacuolar material.

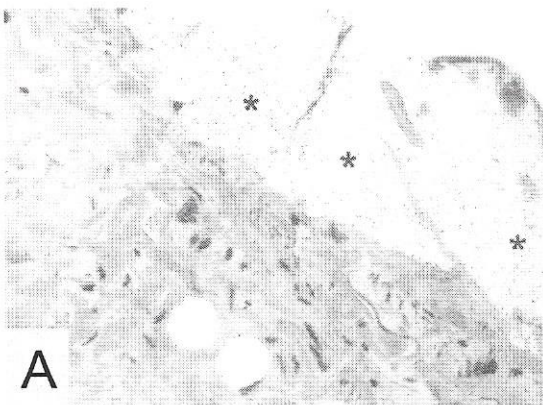
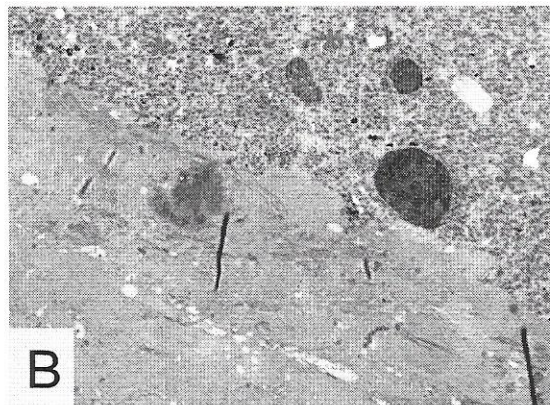
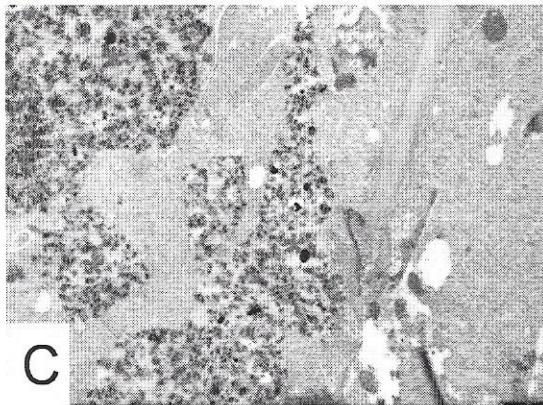
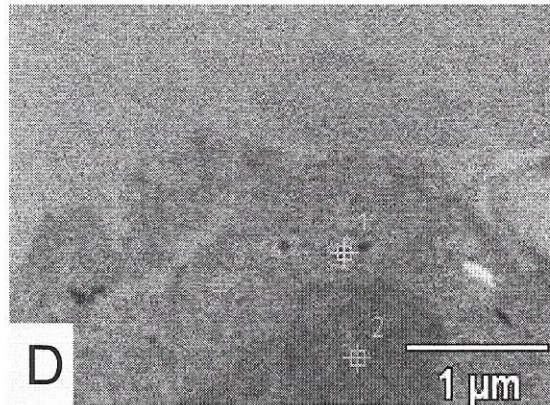
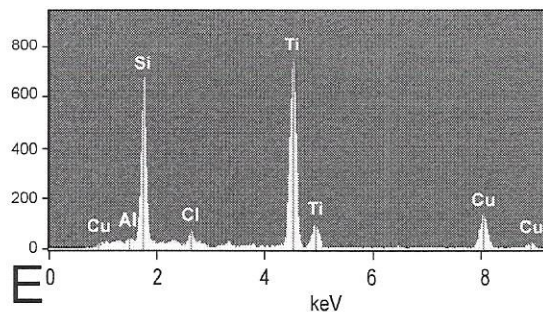
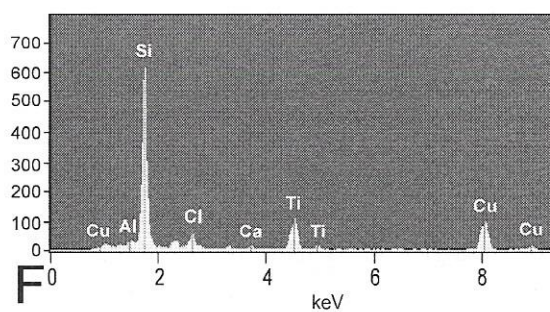
**Figure 6:** Figures show the plaque like structures \* found in the thyroid of patient 1. (A) The toluidin blue stained eponsection, the plaque is located alongside the tissue, suggesting that it has no connection with the tissue; (B) A TEM micrograph where it is nicely demonstrated that the plaque like structure is situated around collagen; (C) A higher magnification of a TEM micrograph where it is nicely demonstrated that the plaques are completely surrounded by thyroid tissue. Dens small particles inside the plaque are clearly visible. EDX analysis is performed on these structures; (D) The TEM micrograph of the EDX measuring points performed on the thyroid of patient 1; (E) Depicted EDX on a dens particle found inside the plaque (spectra 1) = 7200 Si-counts/11652 Ti-counts; (F) EDX on the plaque itself (spectra 2) = 7252 Si-counts/1579 Ti-counts and point 3 is on the surrounding tissue (spectra 3) = 545 Si-counts (not shown). Original microscopic magnifications figure A/B and C, resp. 400x, 3K and 7.5K.

EDX analysis reveals the true nature of the plaque like structures found in the toluidin blue stain, elemental silicon and titanium were found in all the plaque like structures. The found component of elemental titanium represents the dens particles located inside the plaques. Also loose droplets of elemental silicon were found, situated partially in vacuoles, for instance in the thyroid gland, figure 6.

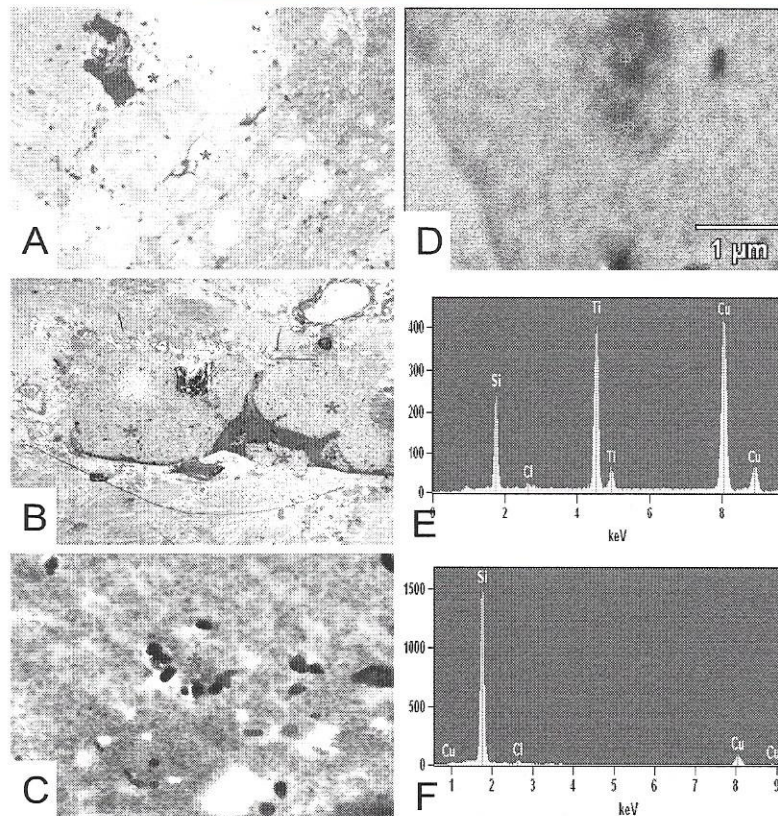
**Figure 7.** (A, B and C) The plaque like structures \* found in the high cervical spinal cord of patient 1. (A) The toluidin blue stained epon section, the plaque is located inside the surrounding spinal cord tissue; (B) A TEM micrograph where it is nicely demonstrated that the plaque like structure is situated around collagen and in close proximity of nerve tissue; (C) A higher magnification of a TEM micrograph where small particles inside the plaque are clearly visible around the asterisk. EDX analysis is performed on these structures and detects Si and Ti, (E); (D) The TEM micrograph of the EDX measuring points performed on the high cervical spinal cord of patient 1 and demonstrates inside the plaque (spectrum 1) = 16854 Si-counts (F). Original microscopic magnifications figure A/B and C; resp. 200 x, 1.5K and 12K.

The plaque like structures found in the spinal cord of patient 1 are located inside the surrounding spinal cord tissue. The TEM micrographs demonstrate the plaque like structure and a higher magnification of a TEM micrograph show small particles inside the plaque, clearly visible around the asterisk. EDX analysis is performed

on these structures (Figure 7 and Figure 8). Measurements are done using EDX-spot-analysis, measuring a surface in the range of 0.1-0.15 square microns. A summary of the EDX-measured Si counts is given in table 2.

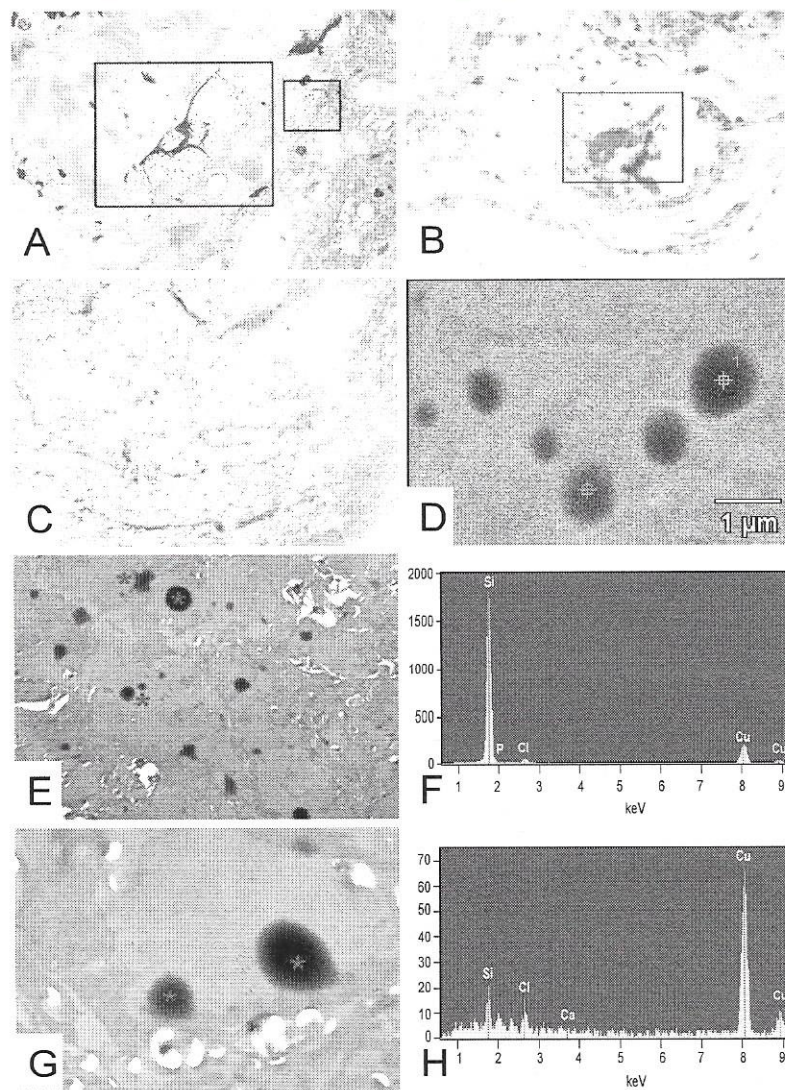
**Figure 8:** (A) Toluidine blue of the spinal cord high cervical, clearly visible is a structure located around collagen, same structures often are positive with MORO staining, reddish plaque is visible (B); (C, D and E) The droplets \* found in the thoracic spinal cord of patient 1; (C) The toluidine blue stained epon section, no visible droplets are detectable; (E) A TEM micrograph where it is nicely demonstrated that there are actually droplets present located inside vacuoles which appear to be partially washed out; (G) A higher magnification of a TEM micrograph where it is clearly seen that the droplets actually are located inside a vacuole and are part of the tissue. EDX analysis is performed on these droplets, figure D shows a TEM micrograph of the EDX measuring points performed on the thoracic spinal cord of patient 1; (F) Demonstrates EDX analysis Point 1 on a droplet found inside vacuolated spaces (spectra 1) = 22211 Si-counts. Point 3 is on the surrounding tissue (spectra 3) = 195 Si-counts (H). Original microscopic magnifications figure A and B 400x, resp. 200x, C-E and G; resp. 50 x, 2.5K and 10K.
